CALSPAN ON-SITE AMBULANCE CRASH INVESTIGATION
SCI CASE NO: CA11004

VEHICLE: 2007 CHEVROLET 3500 EXPRESS VAN
AMBULANCE BODY: WHEELED COACH TYPE II

CRASH DATE: FEBRUARY, 2011

LOCATION: NEW YORK

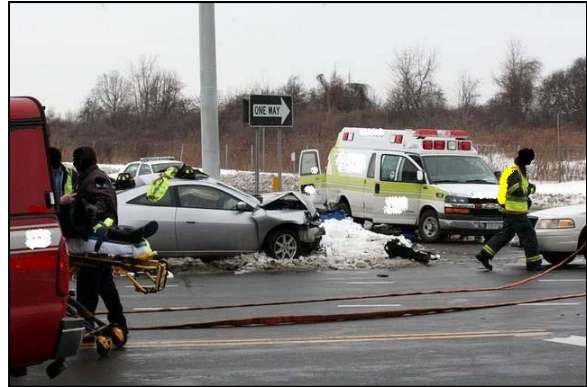
Figure 1 is an on-scene image of the crash site depicting the final rest locations of the vehicles. The crash was identified by the Calspan Special Crash Investigations (SCI) team on February 8, 2011. The notification was forwarded to the Crash Investigation Division (CID) of the

Figure 1: On-scene image of the crash site and the involved vehicles. (Image obtained from an internet news website.)

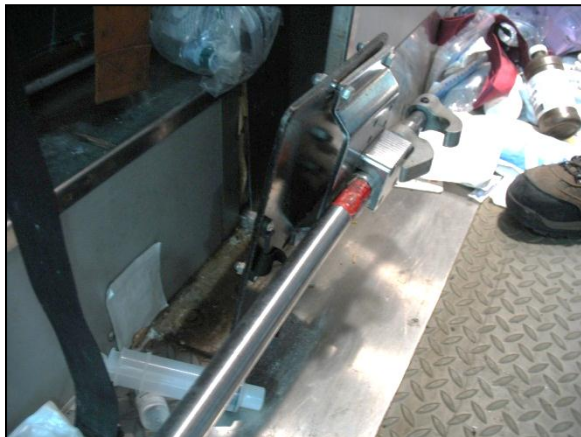
The force of the impact resulted in damage to the ambulance cot. An alloy casting, adjacent to the locking pin that mated to the floor rail clamp (**Figure 4**) mounted within the ambulance, sheared due to an overload force. This damage allowed the cot's movement to become unrestricted. The patient remained restrained on the cot; however, the cot and patient came to rest on its left side (**Figure 5**). The patient was facing the right bench seat. The forward aspect of the cot was entangled with the antler bracket, jamming the cot in the displaced orientation. The first responders freed the forward aspect of the cot and moved it to the left in order to access the patient's head. The patient was stabilized and unstrapped from the cot and then the cot was removed from the ambulance. The patient, who had previously been restrained on a backboard, was loaded into another ambulance and transported to a regional trauma center. The patient sustained multiple left rib fractures, a left hemothorax, bilateral pulmonary contusions and fractures to his left upper and lower extremities. He expired five hours post-crash.

Figure 4: Image of the floor rail clamp located within the ambulance patient compartment.

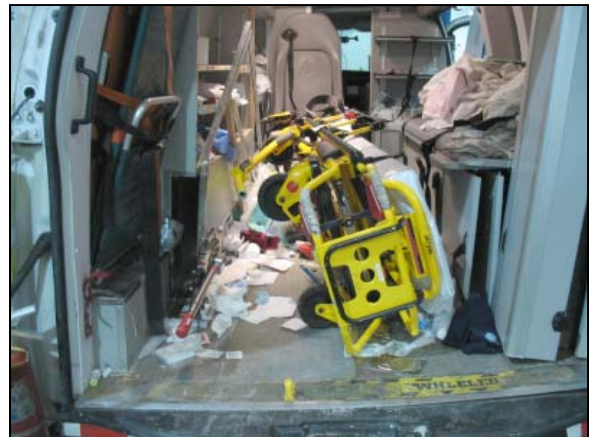
Figure 5: Reconstructed post-crash condition of the ambulance cot.

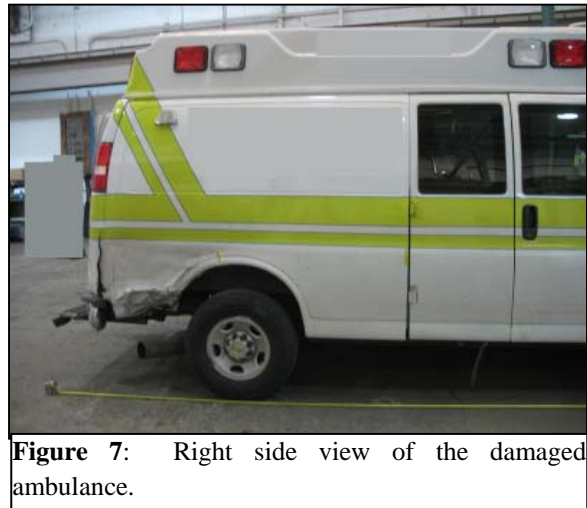
The rear aspect of the ambulance's right plane sustained minor impact damage as a result of this intersection collision (**Figure 7**). The direct damage began 411 cm (162.0 in) aft of the right front axle and extended 102 cm (40.0 in) rearward to the right corner of the rear bumper. The induced damage began 287 cm (113.0 in) rearward of the front axle at the trailing edge of the double-door entry to the patient compartment. The combined length of the induced and direct damage measured 226 cm (89 in). At the right rear corner of the patient compartment, the height of the direct contact measured 89 cm (35 in). The residual crush profile at the lower door elevation was as follows: C1 = 8 cm (3.2 in), C2 = 12 cm (4.6 in), C3 = 0, C4 = 0, C5 = 0, C6 = 0. The maximum crush was located at C2. The C3 and C4 crush measurements were located within the right rear wheelhouse (at the tire) and were taken to be zero. The Collision Deformation Classification (CDC) was 02RBEW2.

Figure 7: Right side view of the damaged ambulance.

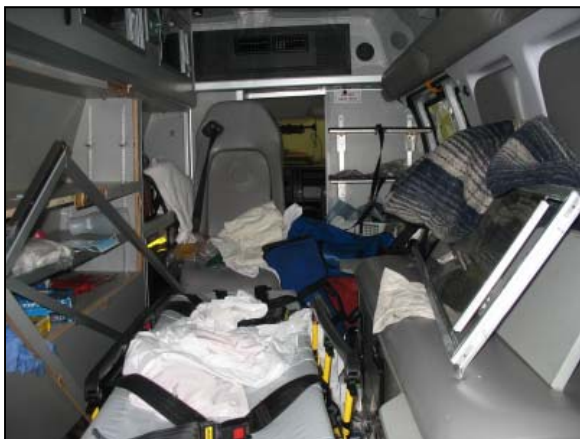
Figure 8: Rear view of the interior of the patient compartment at the time of the SCI inspection.

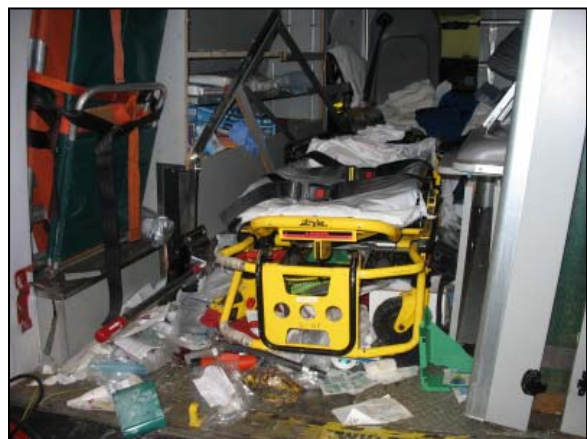
Figure 9: Rear view of the ambulance cot and left patient compartment wall.

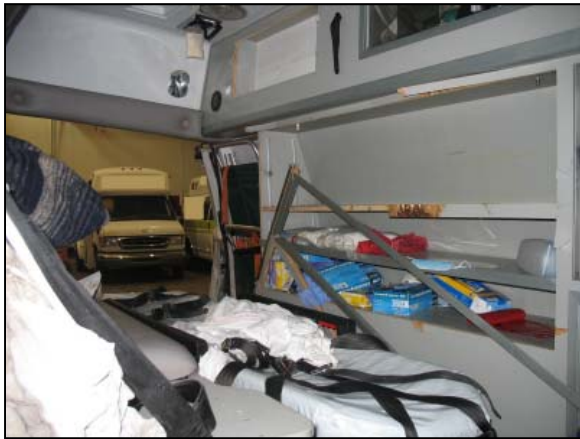
The left wall consisted of three upper cabinets and a large four shelf unit at its center aspect. The upper cabinets measured 66 x 29 x 10 cm (26 x 11.5 x 4 in), length x height x depth. The four shelf unit measured 146 x 100 x 29 cm (57.5 x 39.3 x 11.4 in) in overall dimensions and was enclosed by two sets of sliding doors. The contents, sliding doors, and trim pieces of the rear upper cabinet and the four shelf unit were displaced throughout the interior and onto the patient and EMT during the crash. **Figure 10** is a view of the left interior wall of the crashed ambulance. **Figure 11** is a similar left interior view taken of an exemplar ambulance.

Figure 10: Interior view of the left wall of the crashed ambulance.

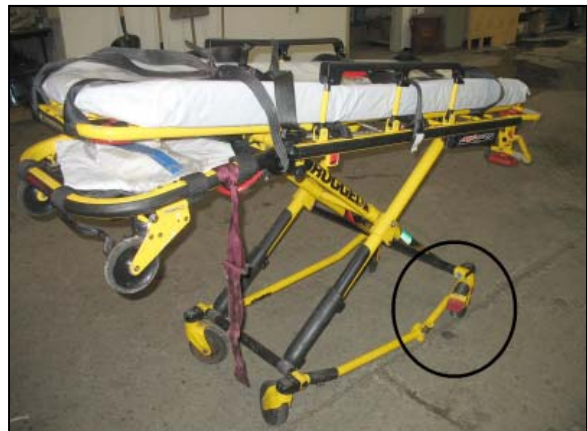
The cot used to transport the patient in this crash was a Stryker Model Number: 6082 MX-PRO R3; Serial Number: 060339888. **Figure 12** is a view of the cot. This cot was constructed of aluminum tubing and was designed for a maximum weight of 295 kg (650 lb). The lower frame of the cot was a scissor design which allowed for height adjustment. The overall dimensions of the cot measured 203 cm (80 in) in length and 58 cm (23 in) in width. The cushion measured 185 cm x 46 cm (73 in x 18 in). The angle of the back rest was set via a pneumatic adjustment. The back rest was flat to accommodate the patient who was laying on a backboard. The patient that was transported reportedly weighed 154 kg (340 lbs) and was within the weight requirements of the cot. The cot was equipped with adjustable side rails. The rearmost vertical support of the left side (relative to the patient) was fractured at its hinged base.

Figure 12: View of the Stryker ambulance cot. The location of the locking pin and sheared tubing is identified in the circle.

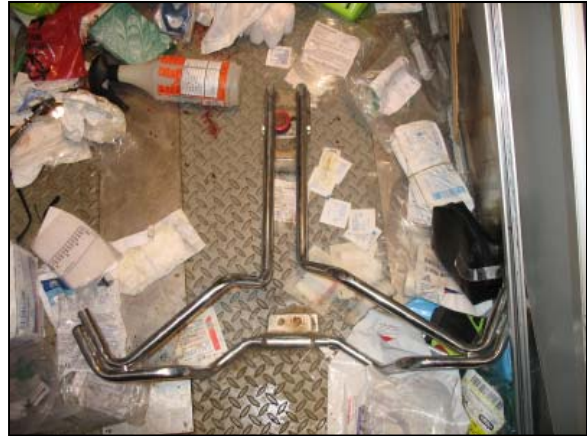
When secured in the ambulance for transport, the forward lower frame work supporting the cot's front wheels nested in the antler bracket that was attached to the ambulance floor (Figure 13). The bracket was secured to the floor of the ambulance by two 10 mm (3/8 in) knurled head cap screws. The forward-most cap screw was sheared off by the first responders in order to disentangle the cot from the antler bracket post-crash. The antler bracket was found loose within the patient compartment, the bracket itself was not damaged.

Figure 13: View of the antler bracket.

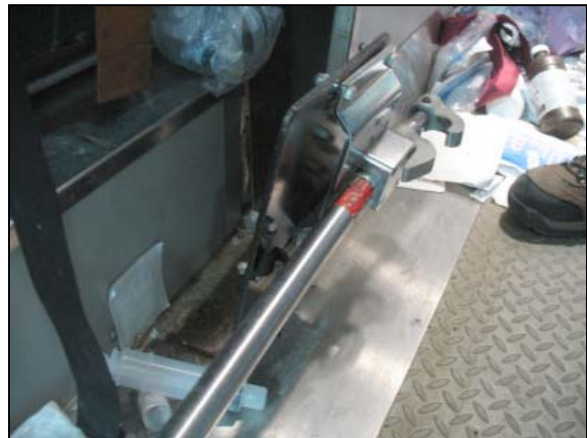
The right rear aspect of the cot was secured to the ambulance by a floor rail clamp. A locking pin that was attached to the lower right tubular frame of the cot, adjacent to the right rear wheel, was secured in the jaw of the clamp. The rail clamp was a Stryker Model 6371 Cot Fastener System (Figure 14). This clamp was the manufacturer's recommended fastener. The clamp was mounted to a 10 cm (4 in) steel angle bracket that measured (11.8 in tall x 8 in wide x 5/16 in thickness). The bracket was secured to the floor of the ambulance by three 10 mm (3/8 in) lap screws. The top of the angle bracket was deformed 5 cm (2 in) inboard. The clamp mechanism was operational.

Figure 14: View of the floor rail clamp.

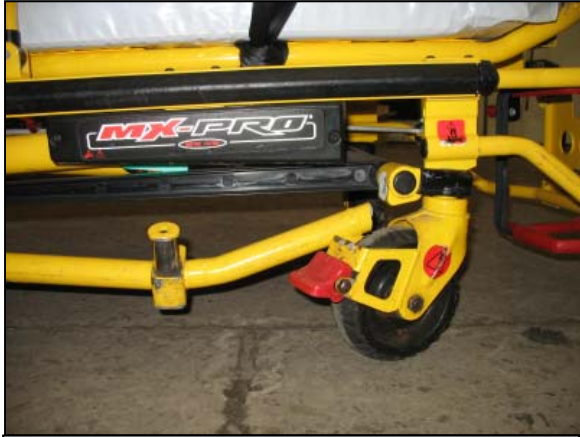
The cot's locking pin was positioned on the longitudinal tubular frame member 24 cm (9.5 in) forward of the right rear wheel. The tubular frame was welded to an alloy casting at the wheel joint. For reference, the location of the casting and the locking pin are highlighted in Figure 12 above. Figures 15 and 16 are close-up views of the casting. During the crash, the casting sheared due to an overload force. The outer diameter of the sheared casting measured 32 mm (1.25 in). This overload force developed due to the rightward kinematic response (acceleration) of the combined mass of the restrained occupant and the cot to the lateral force of the impact. The locking pin and floor clamp were the primary means to couple and restrain the cot and

patient to the ambulance. The overloaded/fractured lower frame allowed the cot to rotate 90 degrees, with the restrained patient and cot coming to rest on their left side post-crash.

Figure 15: Right side view of the locking pin and casting at the right rear wheel.

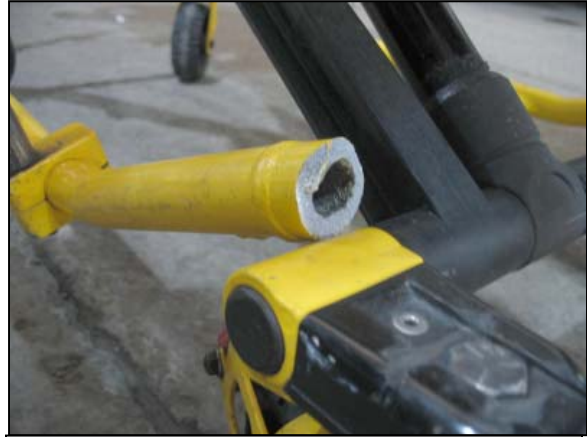
Figure 16: End view of the overloaded casting.

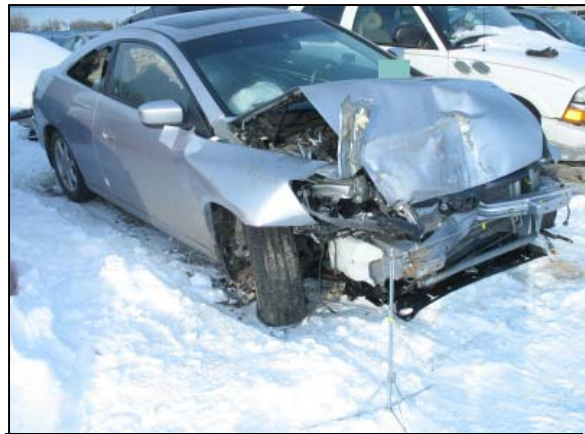
The exterior of the Honda sustained moderate damage to its frontal plane during the vehicle-to-vehicle crash sequence. **Figure 19** is a view of the direct and induced damage to the front plane of the Honda. The direct contact damage began 19 cm (7.5 in) left of the damaged center and extended 96 cm (37.8 in) to the front right bumper corner. The combined width of the direct and induced damage extended across the full 154 cm (60.6 in) end width of the vehicle.

Figure 19: Right front oblique view of the Honda.

The impact resulted in a mostly longitudinal deformation pattern to the front bumper support bar, radiator, hood and front fenders. The plastic front bumper fascia was separated from the vehicle as a result of impact forces. The Honda's right wheelbase was reduced by 9 cm (3.5 in) in comparison to exemplar measurements. A crush profile measured along the bumper level produced the following results: C1 = 3 cm (1.2 in), C2 = 25 cm (9.8 in), C3 = 39 cm (15.4 in), C4 = 36 cm (14.2 in), C5 = 22 cm (8.7 in), C6 = 21 cm (8.3 in). The maximum crush was located 8 cm (3.1 in) left of C3 and measured 41 cm (16.1 in).
